Assessment of Coastal Water Resources and Watershed Conditions at Apostle Islands National Lakeshore (Wisconsin)

Natural Resource Technical Report NPS/NRWRD/NRTR—2007/367

George J. Kraft
Center for Watershed Science and Education
College of Natural Resources
University of Wisconsin –Stevens Point
Stevens Point, WI 54481

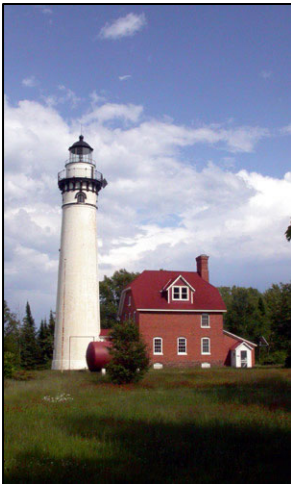
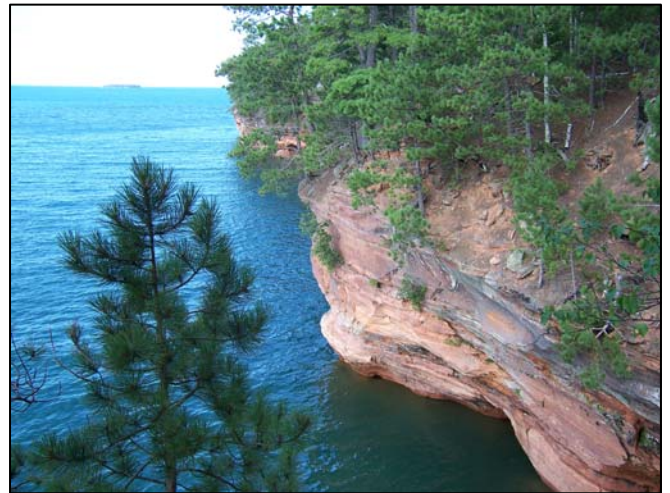
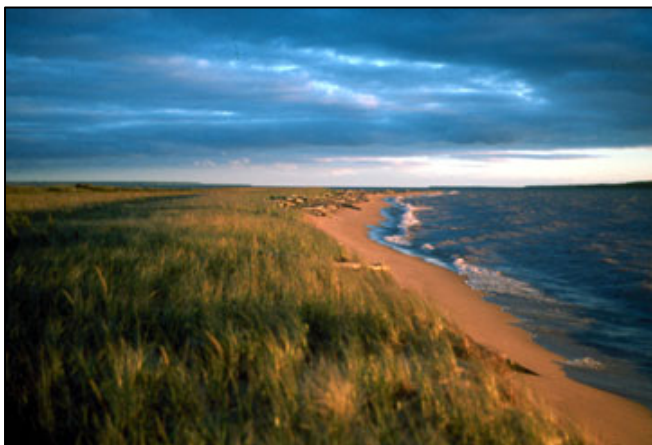
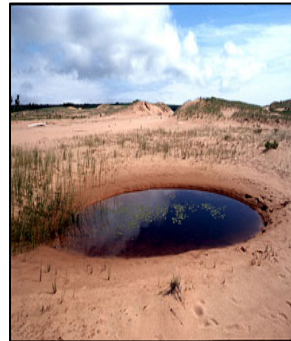
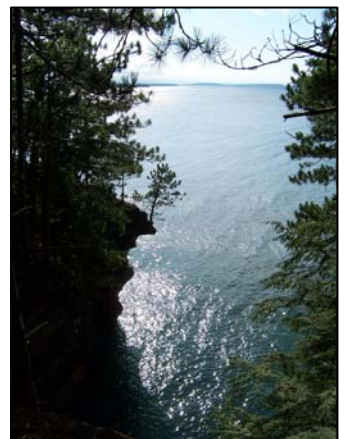
Cover photos:

Top Left: Outer Island Lighthouse, NPS Photo
Top Center: Sand River Estuary, Mainland Unit, Eric Epstein
Top Right: Sea Caves East of Meyers Beach, Mainland Unit, Dave Mechenich
Bottom Left: Outer Island Sand Spit, Eric Epstein
Bottom Center: Stockton Island Tombolo Interdunal Pool, Emmet Judziewicz
Bottom Right: Lake Superior from Trail East of Meyers Beach, Dave Mechenich
